**Second  
International Conference  
on  
Case Histories in  
Geotechnical Engineering**

**June 1-5, 1988**

**University of Missouri-Rolla  
Rolla, Missouri**

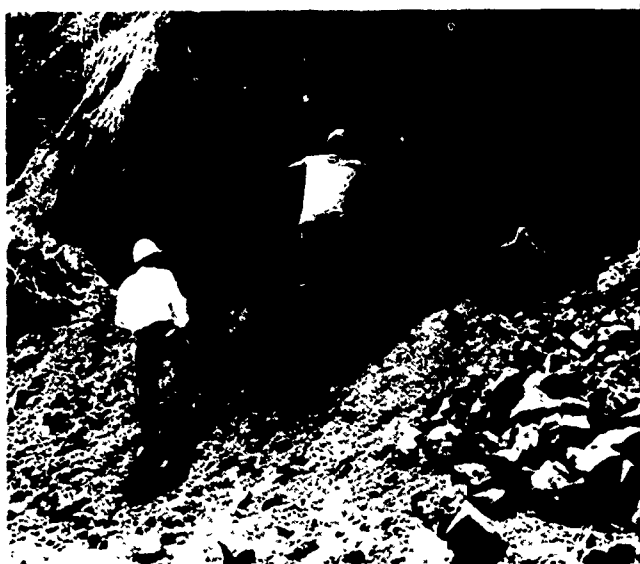
Fig. 2 Outcropping Weathered Rock of the Panama Formation Used for Borrow Landfill Cover

The Panama formation (Early to Late Oligocene) is the principal bedrock unit surrounding the landfill (Figure 2). This rock unit is an agglomerate of angular to subangular blocks of differentially weathered andesite, widely scattered in a matrix of fine-grained tuff (Woodring, 1957; Stewart and Stewart, 1980). Because of deep weathering from the tropical environment, this unit slakes readily to small friable cobbles, chips and mud. Fresh chunks of the Panama formation break easily with both hand and hammer.

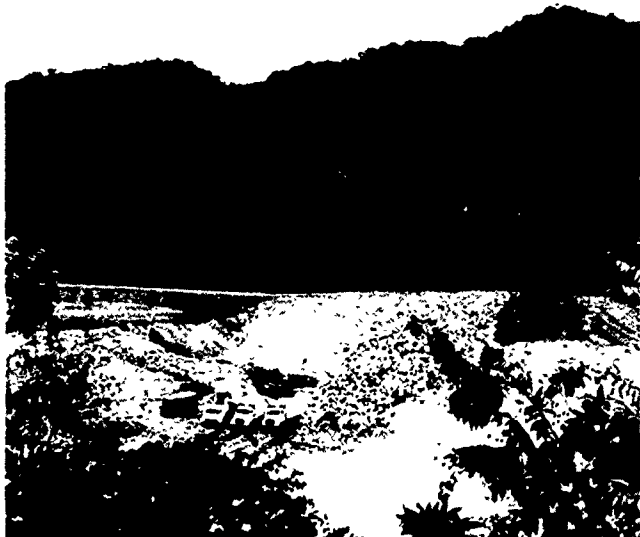
Fig. 4 Operators Employ the Area/Trench Fill Method at Patacon Landfill

The site location for the Patacon Landfill is excellent, if managed properly. The engineers from the University of Panama developed a detailed engineering plan for the landfill site (CONAMA, 1985). There is sufficient acreage and borrow material for the landfill to expand. The engineers estimate that the maximum size of the facility will approach 300 hectares. At the time of the June 1986 survey (Gates, 1986), the City landfilled about 900 tons of solid waste per day by the modified trench-area fill method (Figure 4).

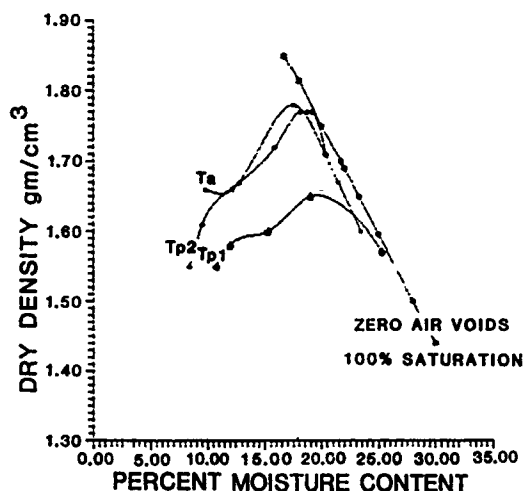
PROCTOR DENSITY RESULTS, PANAMA & ANDESITE UNITS  
PATACON LANDFILL, REPUBLIC OF PANAMA

Fig. 6 Consolidated Proctor Density Results  
Permeability

Figure 6 depicts the combined Proctor density test results. The results show that under ideal laboratory conditions, one can compact the weathered rock to an average Proctor density of  $1.74 \text{ gm/cm}^3$  at an optimum moisture content (OMC) of 19 percent.

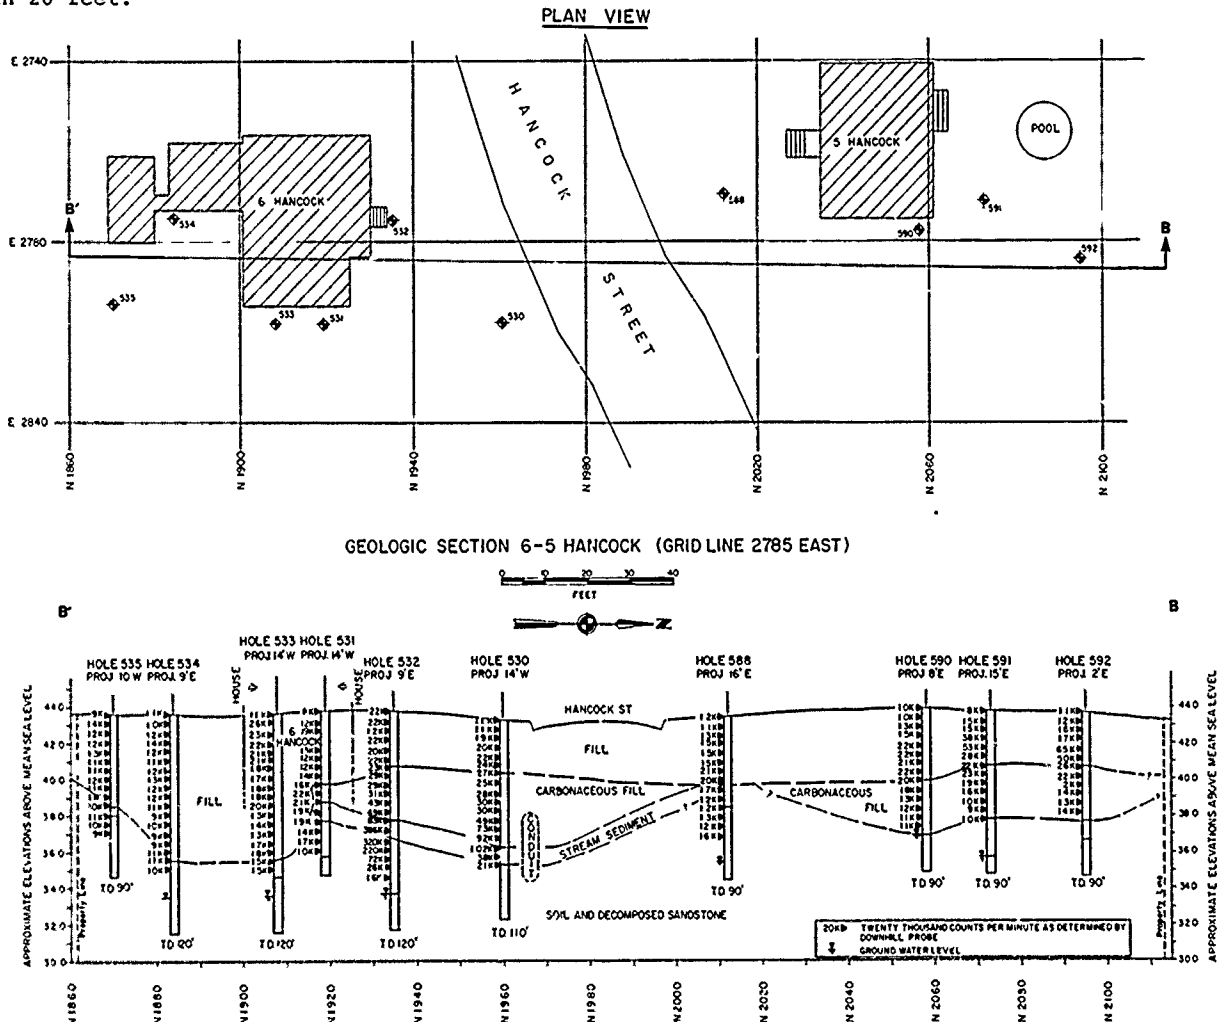
FIGURE II - PLAN VIEW AND CROSS SECTION OF 6-5 HANCOCK STREET

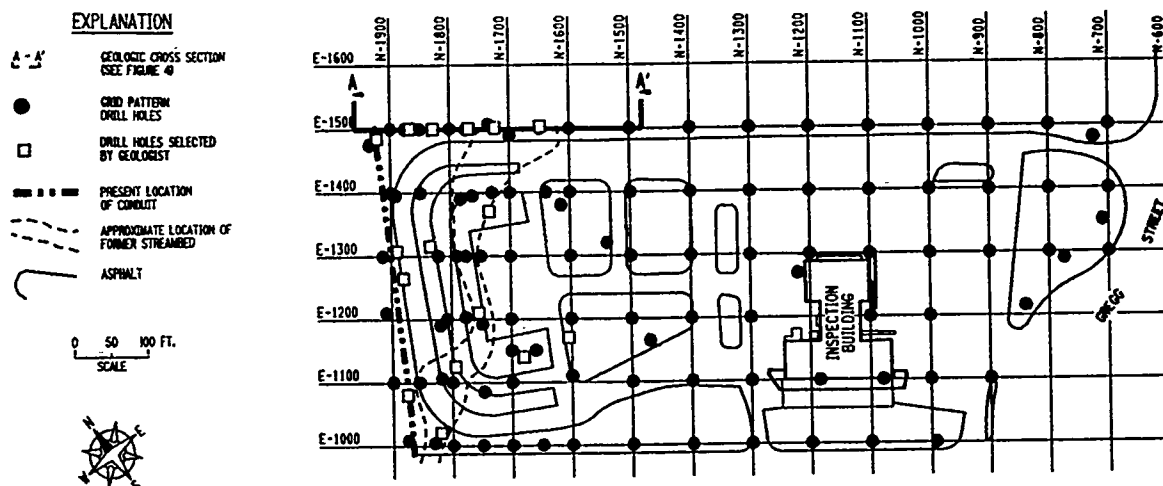
FIGURE III - BOREHOLE LOCATIONS AT THE NEW JERSEY VEHICLE INSPECTION STATION PROPERTY

With these depositional theories in mind, a new drill strategy was developed to take advantage of contamination predictability. From this time on, drillhole locations were selected by the field geologist based on existing drilling and radiologic data and knowledge of shallow geologic conditions. Hole frequencies were increased in areas on top of the former floodplain and decreased outside the high water depositional boundary. Holes were not completely eliminated outside the floodplain due to the fact that contaminated fill was always a possibility. Hole locations were

staggered to provide better coverage for cross-sections perpendicular to stream flow. Fewer holes were needed at each residence because contamination boundaries could be projected down or upstream. And, during drilling, the radiologic logs of each drillhole complimented the geologic logs by helping the geologist better define the contacts between the "hot" black silt sandwiched between clean surface fill and natural decomposed sandstone. This gave us assurance in the field that all contamination had been penetrated.

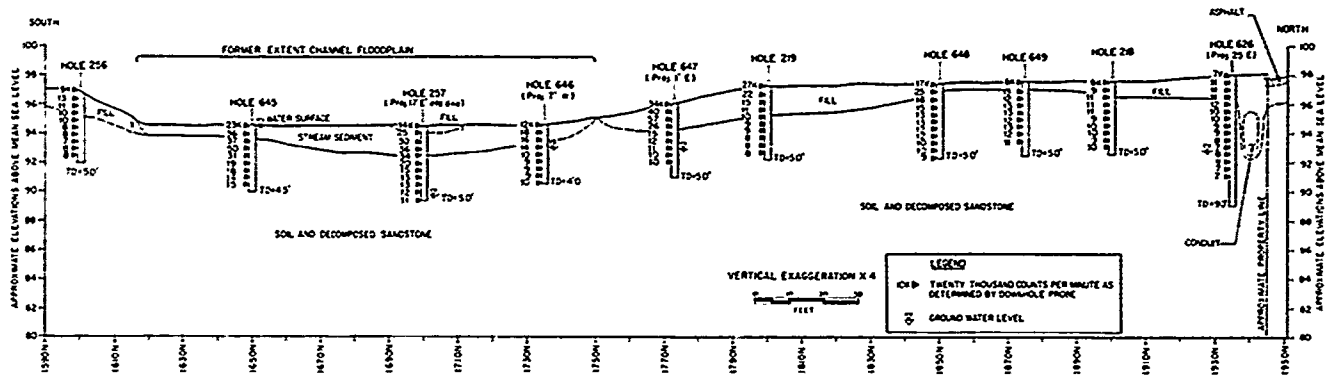
FIGURE IV - GEOLOGIC SECTION GRID LINE 1500E (NEW JERSEY VEHICLE INSPECTION STATION)

The results of the second drill session showed the former channel near the surface and south of the conduit (FIG IV). Contaminated fill was also found around the conduit in the northwestern

corner of the property. Our revised drilling technique provided the information needed for an accurate volume estimate without excess holes. Every hole was used to either define contamination extent and/or depth. Most importantly, the former creek channel was found to be south of the existing conduit, meaning the conduit leaves the former channel somewhere between the southernmost designated Lodi property and the NJVIS. This is valuable information for determining the next properties to be designated for characterization.

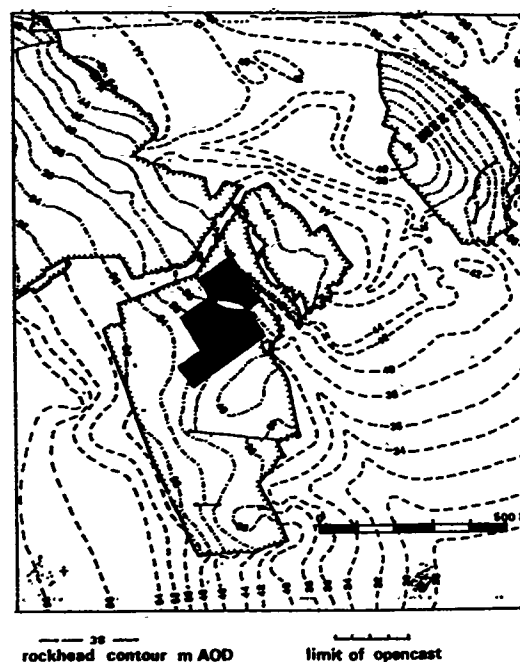
Fig. 2 Rockhead Contours

been observed in the backfill. Interconnected old workings appear to drain to the adjacent North Sea and River Tyne causing permanent drawdown. At different times, some 5 site investigations have been carried out together with an engineering geological mapping exercise, Dearman, W.R. et al (1977), which has defined accurately the position, extent and depth of the opencast workings, Figure 2.

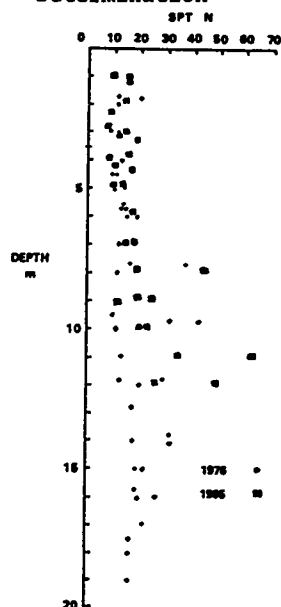
Fig. 3 Standard Penetration Test 'N' v Depth

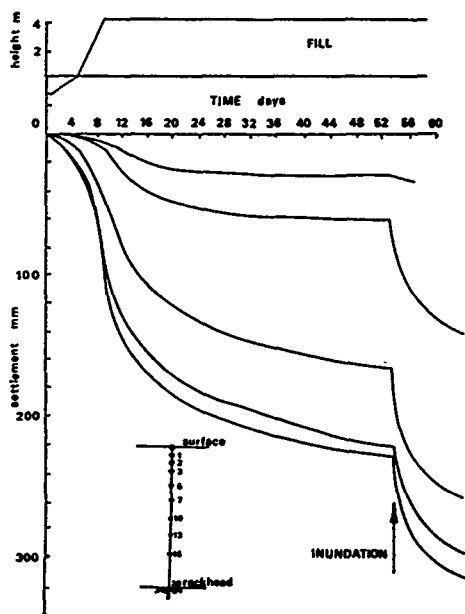
Fig. 4 4m Embankment, Settlement v Time

A surcharge trial has been undertaken involving the construction of three trial embankments, each 20 metre square and 2, 4 and 6 metres high respectively, in the area of the proposed Scheme 3. Magnetic extensometers enabled the settlement at the surface and at 2, 3, 5, 7, 10, 13 and 16 metres below ground level to be determined. Values of constrained vertical modulus were computed by estimating the stress levels at the mid-height of each layer after Giroud and dividing by the observed vertical strain, Table 2. The response of the fill to inundation has been measured in the field by flooding a granular blanket under the 4 metre high embankment after near equilibrium had been established under the surcharge load in the dry conditions. This resulted in collapse compressions occurring but only in the previously identifiable zone of high compressibility between 5 and 13 metres below the surface, Figure 4.

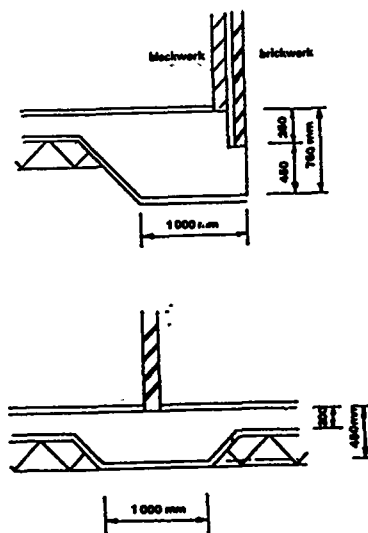
Fig. 5 Foundation Details

The modest building loads transferred to the opencast backfill through the flexible raft foundations are of the order of 30-50 kN/m<sup>2</sup>, Figure 5. Some slight cracking has occurred in places throughout Scheme 1 and 2 which may be settlement related but this has not required remedial work. Observed settlements due to initial structural loads varied from 25-70mm. Some significant additional movement was first noticed in the summer of 1985 after completion of the structural frame, across the movement joint between Area 36/39 and along the South wall of Area 39. Monitoring pins were installed at dam proof course level throughout Scheme 2. Settlement in Area 39 proceeded rapidly initially and then continued at a diminishing rate, Figure 6. The relationships between the maximum total settlement 161mm at W34 and minimum total settlement 23mm at W23, giving a maximum differential settlement of 138mm which plots well outside quoted limits for building on raft foundations. The relative rotation across the building is much higher than load bearing walls would be expected to accommodate, Table 3.

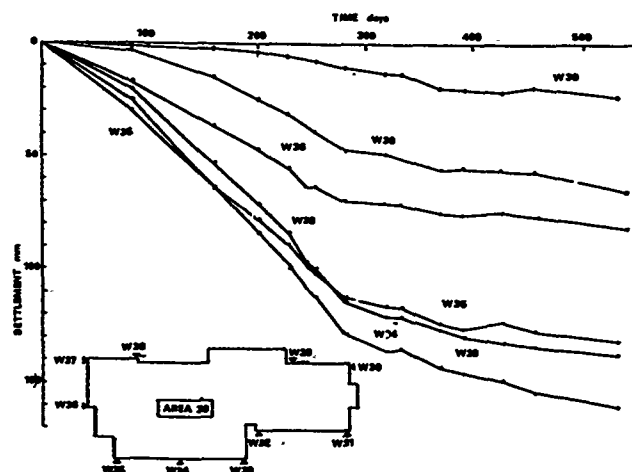
Fig. 6 Area 39: Settlement v Time

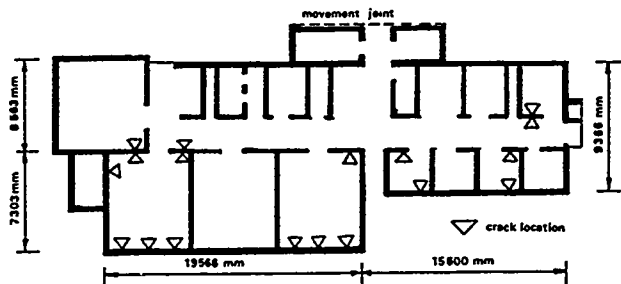
Fig. 7 Area 39: Crack Locations

Internally, some minor cracks have appeared in the plaster finish of the long corridor walls at floor level adjacent to doors and windows and along the south elevation at the locations indicated, Figure 7.

Openings reduce wall stiffness and act as stress concentrators. No cracking has been observed in the external brickwork other than hairline cracks in the mortar bed joints around the windows on the south elevation. This reactivation of settlement under constant load has been attributed by the Author to wetting-up of the opencast fill from an, as yet, unidentified source. Because the foundation raft is relatively flexible it is the configuration and stiffnesses of the walls which control redistribution of contact stress, differential settlement and resulting crack patterns. This subject forms a continuing area of research at the University of Newcastle upon Tyne.

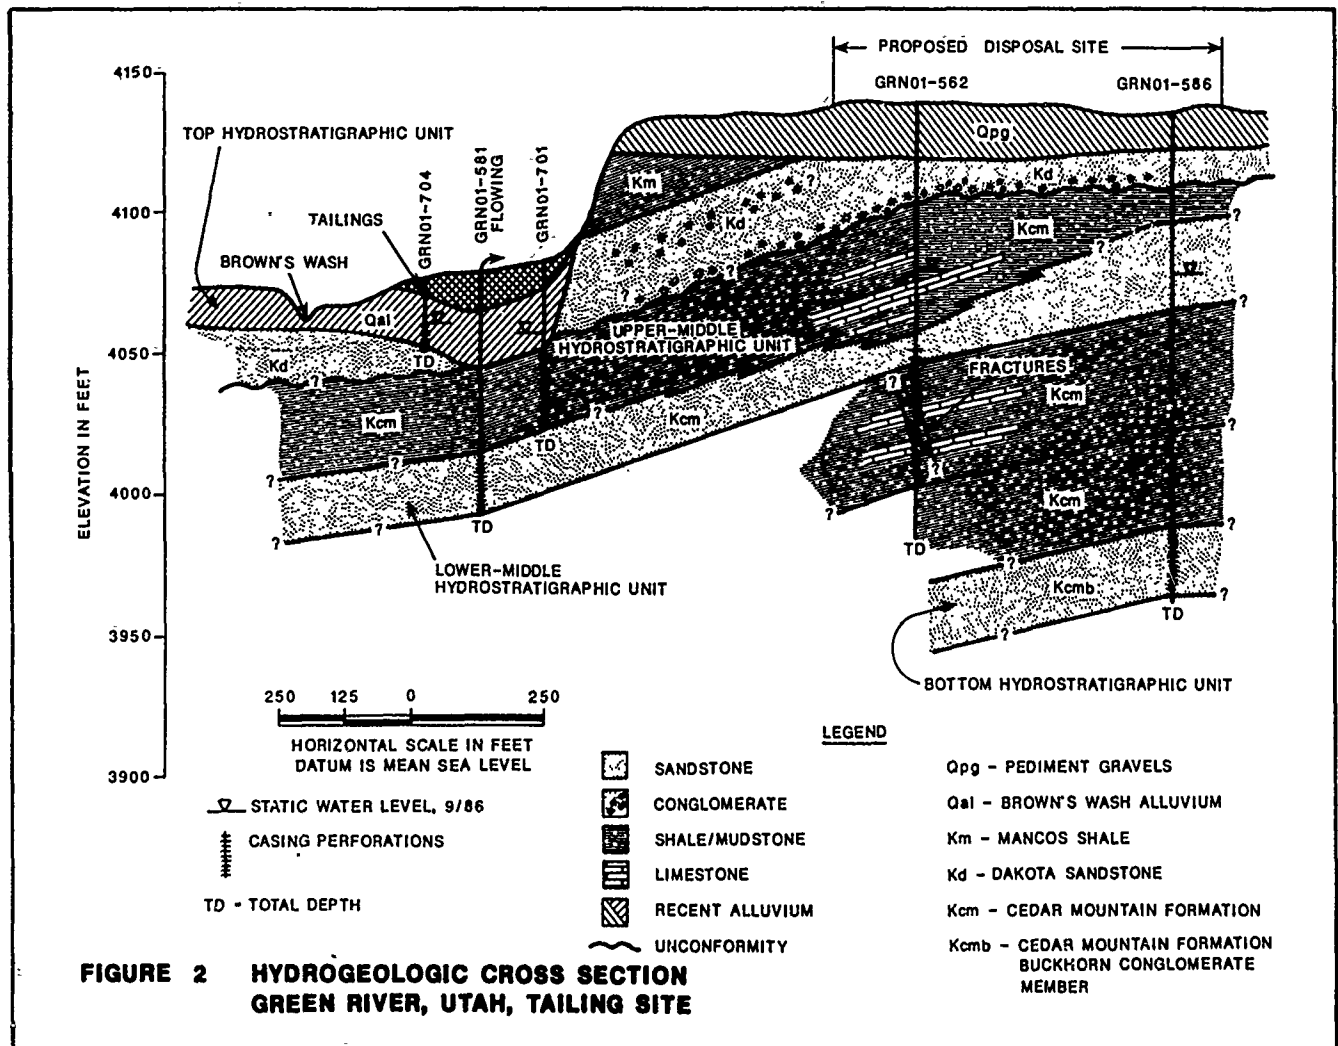
Geologic cross sections were developed from outcrop and borehole information. A typical cross section is shown on Figure 2. The conditions at the site reflect the regional bedrock configuration of shallow dipping beds of Mancos Shale overlying a thin and discontinuous layer of Dakota Sandstone which in turn overlies the Cedar Mountain Formation.

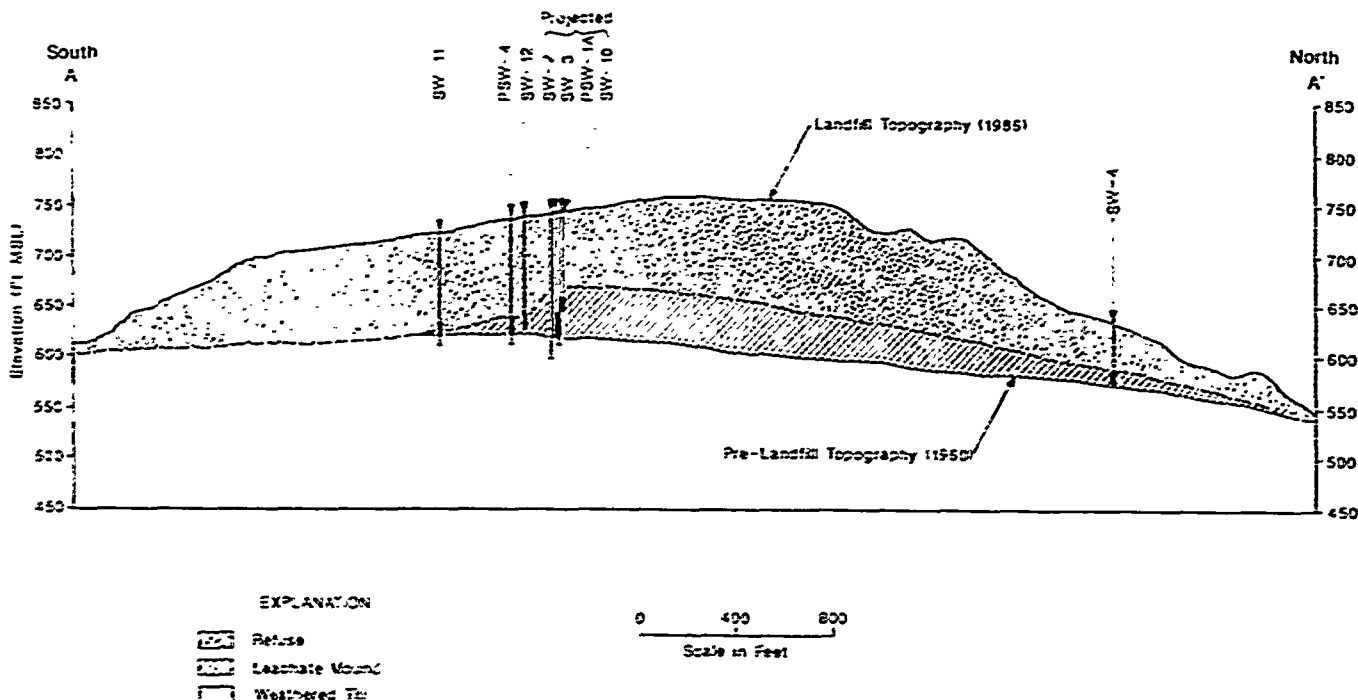
Figure 3. Cross-Section A-A'

Figure 3 shows the approximate configuration of the leachate mound. Along the north-south axis, the mound is roughly 3,450 feet in length. The extent of the mound along the east-west axis is unknown. The leachate mound is thin toward the north perimeter of the Main Hill and toward SW-11. Several perched leachate production zones were observed during drilling, however the quantity of leachate in these zones appeared small.

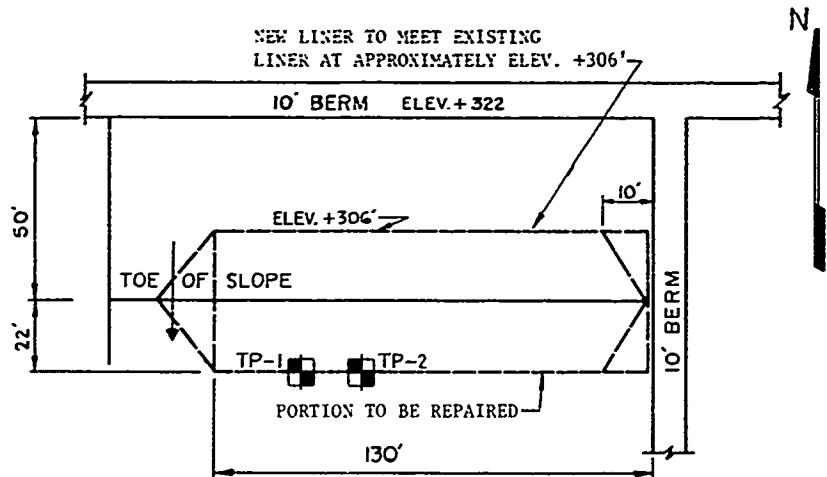
FIGURE 2- PLAN VIEW OF THE CENTRAL PORTION OF THE NORTH SLOPE SHOWING CONDITIONS AND THE EXTENT OF REMEDIAL WORK TO BE DONE.

NOTE: DIMENSIONS SHOWN ARE TENTATIVE. THE EXACT EXTENT OF THE AREA OF REMEDIAL WORK IS TO BE ADJUSTED BASED ON FIELD CONDITIONS.

- EXISTING SLOPE EDGES
- APPROXIMATE BOUNDARIES OF REPAIR AND ADDITIONAL FILL
- LONGITUDINAL FOLD IN HYPALON LINER
- TEST PITS AT LOCATION OF UPHEAVED SOIL AND RIPPED LINER

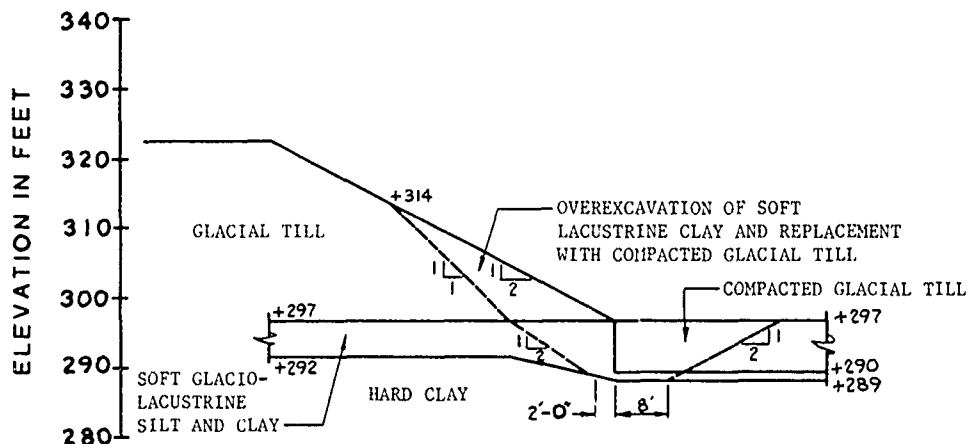
FIGURE 4- NORTH SLOPE REMEDIAL WORK - ALTERNATE NO. 1

Two alternates were proposed for the remedial construction of the slope. The details of the first alternate are shown in Figure 4. In order to reconstruct the limited portion of the north slope to its original configuration, the disturbed soft clay soils within the area of the toe of the slope would have to be removed. A stable slope configuration, as initially constructed, would require overexcavation and replacement of soft clay soils to a depth of approximately six feet at the toe of the slope, as well as up the side of the slope, to the contact with the overlying glacial till. The overexcavation work would require that limited areas be excavated and filled with suitable compacted material in order to minimize potential slope failure during remedial earthwork.

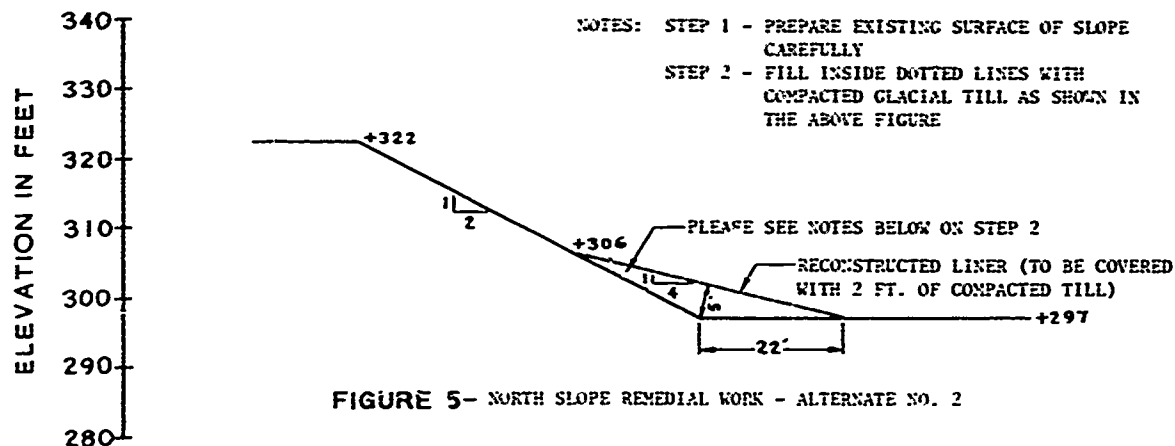
FIGURE 5- NORTH SLOPE REMEDIAL WORK - ALTERNATE NO. 2

Details of the second alternate proposed are shown in Figure 5. Implementation of this solution would require that the disturbed soft clay soils be removed to the initial slope configuration and a layer of compacted glacial till at least 4 to 5 feet in thickness be placed above the toe of the north slope prior to replacing the membrane liner. This solution would flatten the final slope in the region of the disturbed soft clays, and would provide a blanket of compacted fill above the in-place soft clay soils to minimize the effects of future settlements due to consolidation of the underlying soft clays. It is felt that this alternate would provide a suitable base for the reconstruction of the liner without creating potential safety hazards during remedial construction which would be involved with any

extensive overexcavation of the soft clays. Hence, this alternate was selected for the remedial construction.

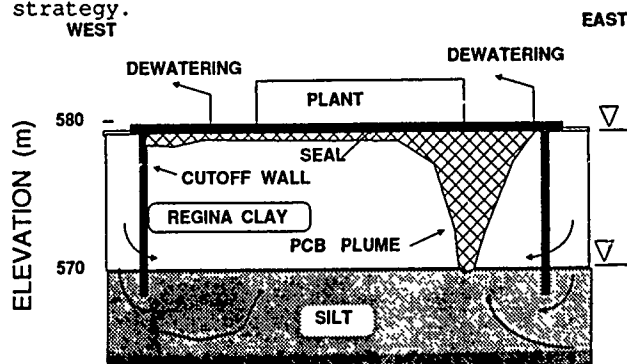
Fig. 3 Conceptual Sketch of Containment System

The fundamental principle on which this strategy involved severely limiting and possibly reversing the hydraulic gradient in the fill and clay beneath the site. Since the supply of PCB's had been cut off the primary downward driving force was the natural downward movement of moisture through the clay. This downward movement is driven by water in the fill replenished by precipitation through the year. The goal of the remedial measures plan was to seal the surface of the site preventing the recharging of the perched water table and forcing a reversal of the hydraulic gradient. To aid in this reversal, the perimeter of the site was ringed with a cutoff wall extending down through the clay to the silt. Shallow sumps were installed to dewater the fill. Figure 3 shows an east west cross section through the zone of deepest contamination. This figure conceptually illustrates how the cutoff wall, surface seal and dewatering combined to enhance the containment strategy.

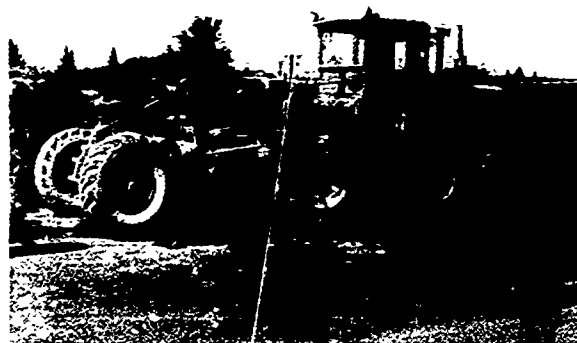
Fig. 7 Decontamination of Construction Equipment at Washdown Facility.

This facility proved difficult to maintain and a more permanent installation was constructed. This facility was established over a concrete sump located at the rear of the plant (Figure 7). This sump was turned into a washdown facility by installing a heavy steel channel iron grate capable of supporting large construction equipment.

All equipment used to excavate or handle contaminated soil was washed in these facilities. Washing consisted of alternately spraying the equipment with acetone and hexane. These facilities were also used to decontaminate drilling and sampling equipment.

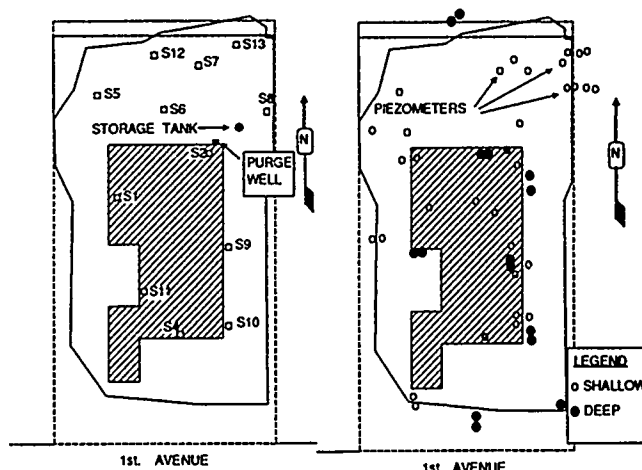
Fig 9a. Location of Dewatering Sumps

The location of the shallow dewatering sumps used to dewater the fill are shown in Figure 9a. This figure also shows the location of the storage tank used to hold the water removed from the sumps. In addition, a purge well was located at the center of the PCB plumb near the location of the pipe line break. A total of 13 sumps were installed. Three of these sumps are located inside the plant. Sump 6 is the concrete lined sump used to decontaminate excavation equipment. Sump 8 is an old Askarel sump.

The location of the most frequently recorded piezometers is shown in Figure 9b. A total of 73 piezometers have been installed on this site. Most of these piezometers were read on a weekly basis since completion of the remedial measures.

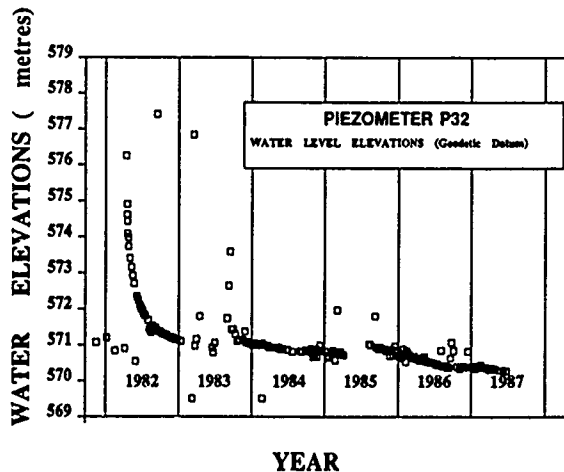
Fig. 10 Variation in Water Elevation with Time for Deep Piezometer No. 32

A typical piezometer profile over the past six years is presented in Figure 10. This piezometer is located inside the north wall of the plant. The base of the piezometer is located in sand lenses in the silt. This piezometer was flooded in 1982 to measure its response. Since that time the water level has been dropping yearly to its 1981 value of 570.3 m. This and some of the other deep piezometers have shown a tendency to drop slightly during summer as a result of the dewatering, and increase in elevation during the winter.

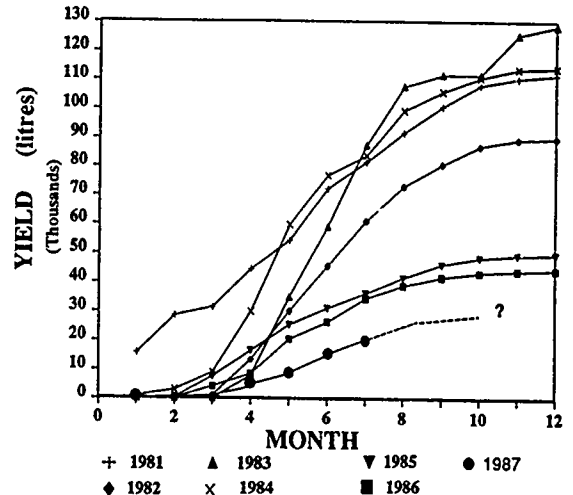
Fig. 11 Cumulative Yield From Dewatering Sumps From 1981 to 1987.

The volume of water removed from the sumps has shown a considerable decrease since the installation of the remedial measures. Figure 11 shows the cumulative yield from these sumps for the past seven years. The cumulative yield values start in January and end in December as the 12th month. The second phase of the remedial measures was carried out in 1984. The volume of water

extracted from the sumps has fallen every year since, to near one-third of its 1984 level by 1986. The 1987 values indicate further improvement.

Figures 11 and 12 clearly show that further improvements in restricting inflow are possible. However, most of the obvious sources of infiltration were dealt with in the 1984 improvements. The one source of possible infiltration causing some concern and not dealt with at that time was the quality of the seal over the Interim Storage Facility. Sump 8 located a short distance north of this facility has consistently been the leading source of water. In addition the height and geometry of this facility made placement and compaction of the asphalt surface seal very difficult. As a result cracks of up to 100 mm opened every spring along the sides and top of this facility. These cracks were sealed with various asphaltic compounds on a regular basis. However, the cracks still re-opened. A number of attempts were made to check the possible influence of this facility by placing

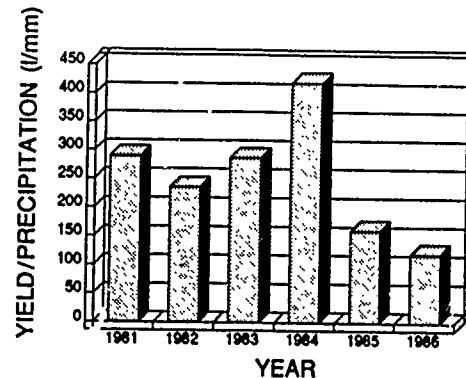
Fig. 12 Variation in Yield Versus Precipitation

Another illustration of the improvement in the surface seal is shown in Figure 12. It presents a comparison of the ratio of sump yield in litres to precipitation in mm. The figure clearly illustrates the connection between precipitation and infiltration. It also demonstrates the effectiveness of the 1984 remedial measures in lowering infiltration through the surface seal.

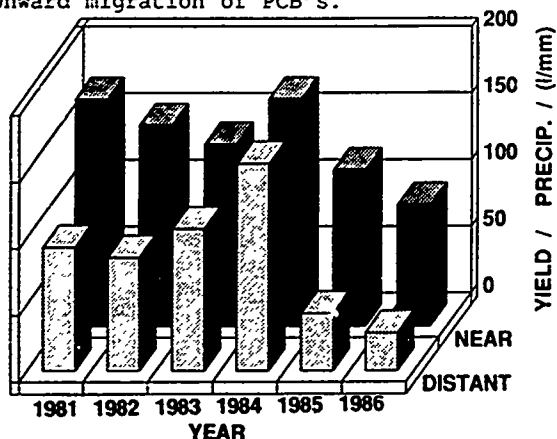
Fig. 13 Comparison of Yield Versus Precipitation Ratios for Sumps Located Near and Far Away From The Interim Storage Facility

A further analysis of the present situation can be made by examining the cumulative yield versus precipitation relationships for sumps located near a far away from the Interim Storage Facility (Figure 13). This figure shows that the ratio of yield to precipitation is considerably higher for the sumps located near the Interim Storage Facility.

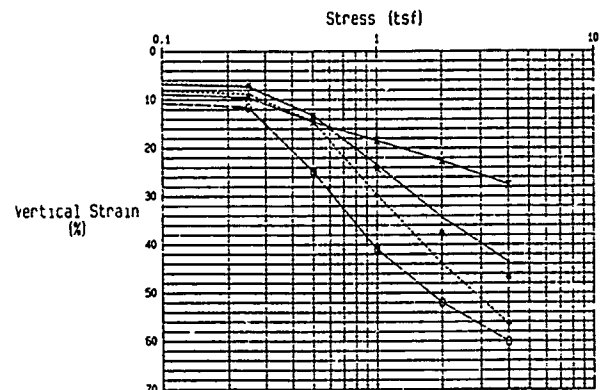
Figure 3. Compression Curves of Wetland Deposits

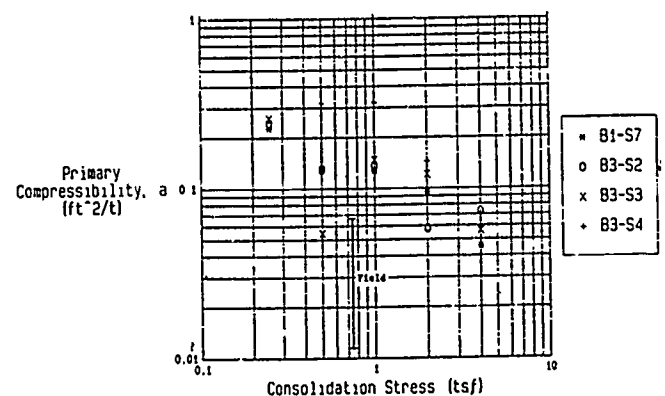
Figure 4. Primary Compressibility versus Consolidation Stress

The laboratory compression curves (vertical strain versus time) under different increments of stress have been evaluated using the compression equation given above to obtain the parameters resulting in the best possible fit of the equation to the measured data. Figures 4 and 5 provide a plot of parameters  $a$  and  $b$  as a function of the stress level used in the laboratory tests. These curves show trends noted before for similar soils from other sites (Edil and Mochtar, 1984). There is a decrease of compressibility with increasing stress. Figure 6 shows the rate factor for secondary compression ( $\lambda/b$ ) as a function of the average strain rate ( $\dot{\epsilon}$ ). Average strain rate is defined as the final measured strain divided by the lapsed time under a given increment of stress applied.

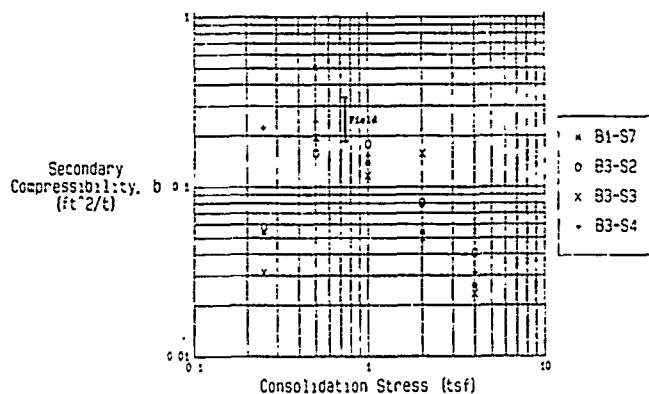
Figure 5. Secondary Compressibility versus Consolidation Stress

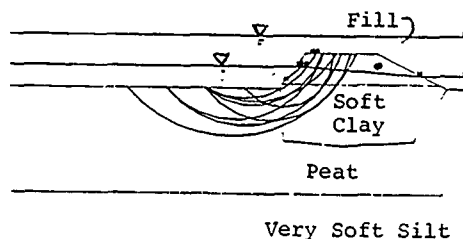
10 MOST CRITICAL OF SURFACES GENERATED  
MINIMUM FACTOR OF SAFETY = 1.19572

Figure 7. Stability Analysis Section and Critical Failure Surfaces

A series of stability analyses for a cross section (see Figure 7) through the south dike of Lagoon 2 near the west end of the 1973 failure zone was performed. This section was considered to be a critical section based on the thicknesses of the soft soil deposits and the geometry of the embankment. Furthermore, the most detailed account of soil properties and the stratigraphy was available at this location. Initially, it was assumed that all of the excess pore pressure in the peat underlying the fill had completely dissipated. In effect, the pore pressures in the underlying soils were set equal to the hydrostatic pressures produced by the lagoon and canal water elevations. Other analyses were made in which the pore pressures in the peat were higher than the hydrostatic pressure. There were also analyses performed in which the soil properties were varied within the perceived range of uncertainty. All of the analyses used an effective stress approach and were performed using the STABL computer program (Siegel, 1975) which is based on the limiting equilibrium method of slices for circular and non-circular failure surfaces. A summary of safety factors as a function of amount of excess pore water pressure assumed in the peat layer (0, 100, and 200  $\text{lb/ft}^2$ ) is given in Figure 8 for different assumptions about the soil properties and the choice of analysis. These analyses indicated the following (Edil and Bosscher, 1985):

- 1 Under the hydrostatic pore pressure regime, the cross section was quite stable.
- 2 The slope on the lagoon side was found to be more unstable than the slope on the canal side.
- 3 The presence of excess pore pressures in the underlying peat layer is very significant relative to stability.
- 4 All of the critical failure surfaces were confined basically to the upper peat layer.

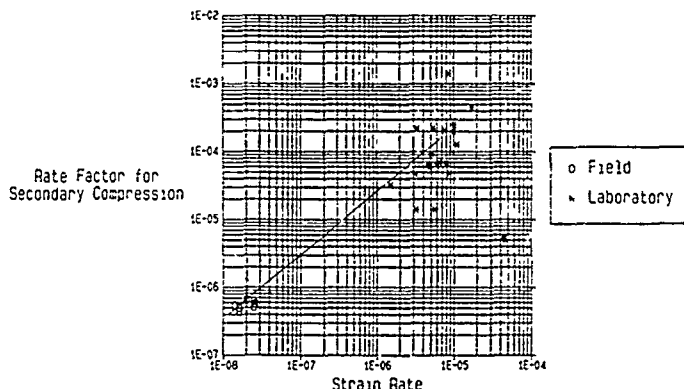
Figure 6. Rate Factor for Secondary Compression versus Strain Rate

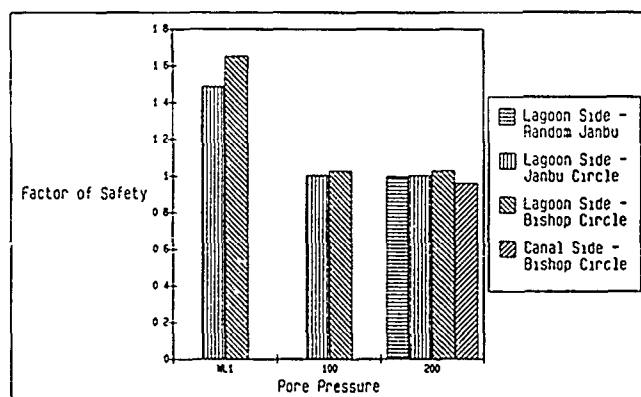
Figure 8. Safety Factors for Different Pore Pressures  
[WL1=Hydrostatic Pressure; 100,200=Excess Pore Pressure ( $\text{lb/ft}^2$ )]

It is clear from this analysis that the presence of residual excess pore pressures induced by the weight of the fill (dike material) and additional pore pressures due to upward ground water discharge can reduce the stability of the dike slope to near critical levels. Since the lagoons lie within a groundwater discharge zone (as indicated in the previous studies), upward seepage should be investigated relative to stability.

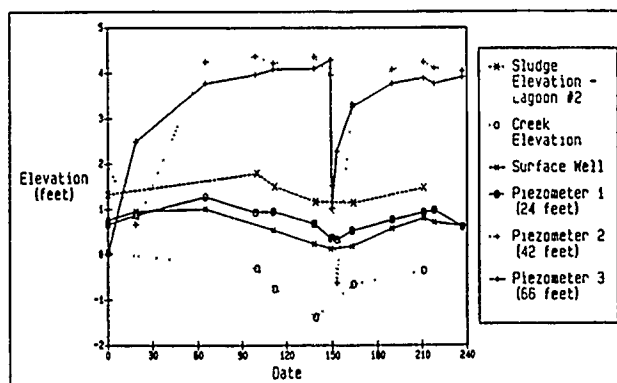
Figure 9. Ground Water Level and Pore Pressure Measurements

The data has been collected since late February, 1987 upon completion of the instrument installation. The water level data has been used to support the assumptions made in the dike stability analysis. The results as obtained from the monitoring instrumentation near boring B-14 are presented in Figure 9. The measured piezometric levels are similar to the values assumed during the analysis phase. It can also be noted that the previous assumptions of the region being a groundwater discharge zone is substantiated (see piezometric levels in Piezometers 2 and 3 compared to the surface well). The dramatic dip in the piezometric levels around early August in Piezometers 2 and 3 is due to pumping of these piezometers to determine the response of the system. It should also be noted that the surface well water elevation lies between the creek elevation and the sludge elevation, the two boundary elevations.

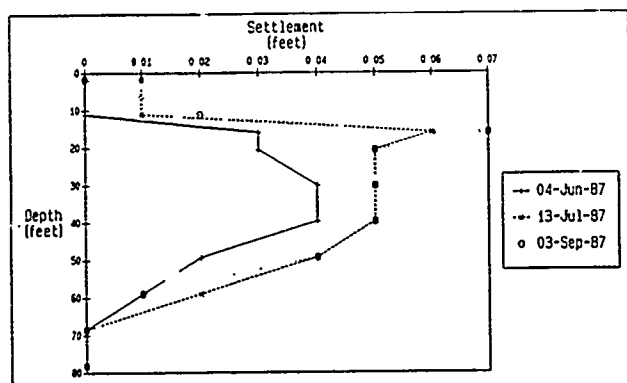
Figure 10. Settlement Measurements

The settlement data has been reduced and plotted in Figure 10. This figure indicates the small amount of settlement which can be measured using the Sondex system. The data is presented with the amount of settlement assumed to be zero at the time of installation. Even with only 240 days of settlement, the results show that the settlement is zero in the mineral soils at +68 feet, and the settlement occurring mainly in the soils in the 40-68 ft depths. Additional settlement can be seen in the 15-20 ft depth. The Sondex pipe was riveted to the inclinometer pipe at

the ground surface which is thought to account for the reduction in measured settlement at the ground surface. Based upon the measured rate of 0.07 feet occurring in 240 days, the additional total settlement expected between now and the year 2000 is under 1.5 inches assuming a logarithmic decline in the settlement rate. This value compares well with the previous prediction of less than 2.0 inches.

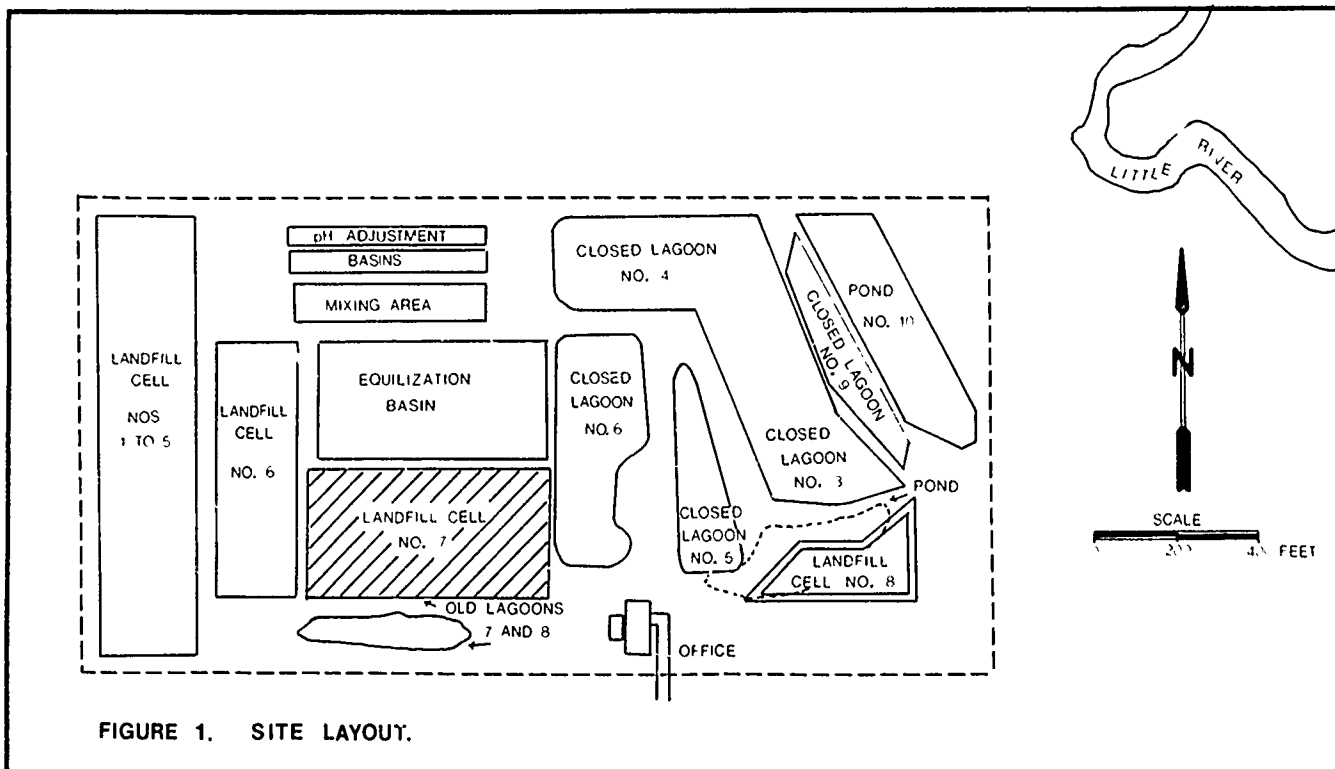
FIGURE 1. SITE LAYOUT.

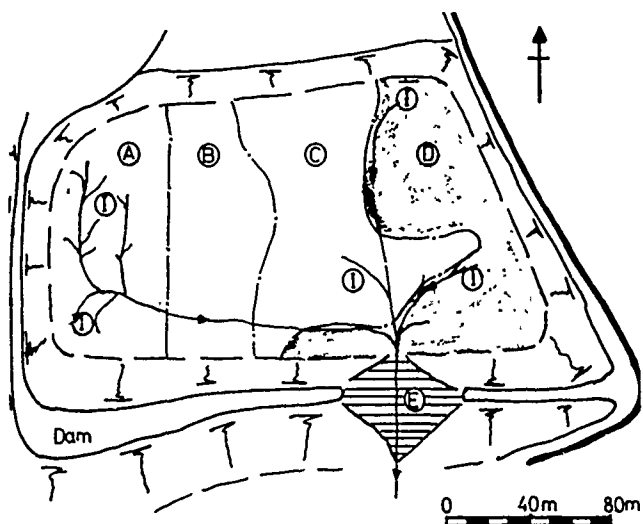
Zone A: Natural liner = 0 to 0.5m thick - more clay needed  
 Zone B: " " = 0.5 to 1.0m " " "  
 Zone C: " " = 1.0 to 1.5m " - satisfactory  
 Zone D: " " = greater than 1.5m thick - source of suitable clay  
 Zone E = Dam breach I = Groundwater issue

Fig. 2 Cell 4

The first thing to be done was to identify the zones where there was already an adequate natural liner (low permeability clay not less than 1m thick) and the zones where additional clay was required - as shown in figure 2. This investigation was undertaken by hand auger. "Undisturbed" samples of clay were taken using a 4" (102mm) diameter cutter driven into the ground to obtain a plug of soil approximately 4½" (114mm) long which was then subjected to a falling head permeability test. All of the samples tested had permeabilities in the range  $0.10$  to  $0.60 \times 10^{-7}$  cm/sec. so that this material would satisfy the local authority requirements for

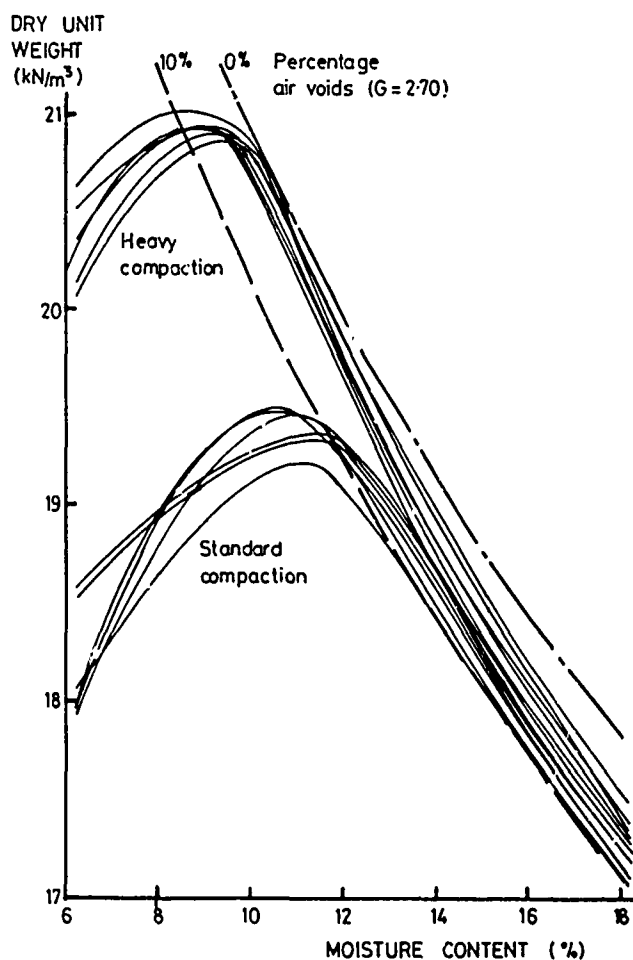
Fig. 3 Compaction Curves

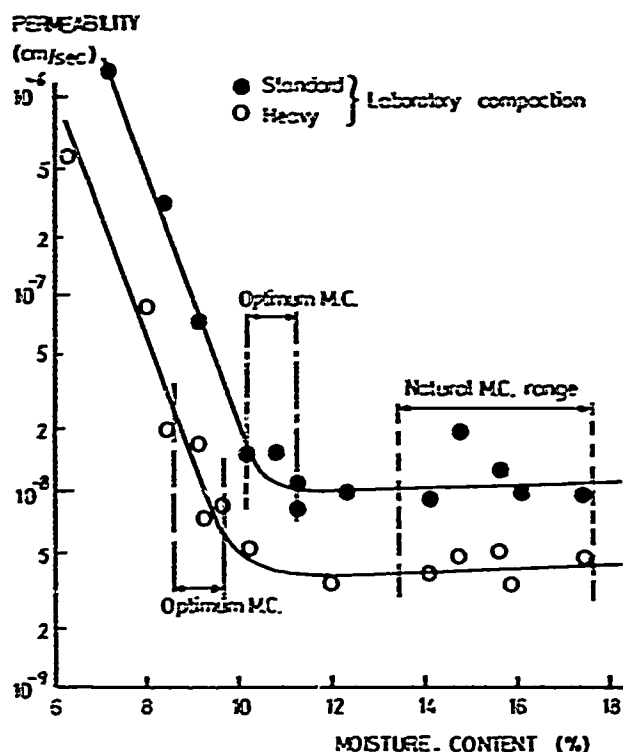
Fig.4 Effect of Moisture Content on Permeability

The results from the permeability test programme, which are presented in figure 4, agree with the trends reported by Daniel (1984). The data show several important points:

- i) On the 'dry side of optimum' the coefficient of permeability (k) increases rapidly as moisture content and dry unit weight decrease.
- ii) Minimum permeability is obtained when the clay is compacted slightly 'wet of optimum'.
- iii) On the 'wet side of optimum' the permeability is virtually independent of moisture content (at preparation) or dry unit weight.
- iv) Increased compactive effort decreases the permeability - in this case by a

factor of approximately 3 in going from standard to heavy compaction.

- v) Clay compacted at natural moisture content had a permeability less than 10<sup>-7</sup> cm/sec.

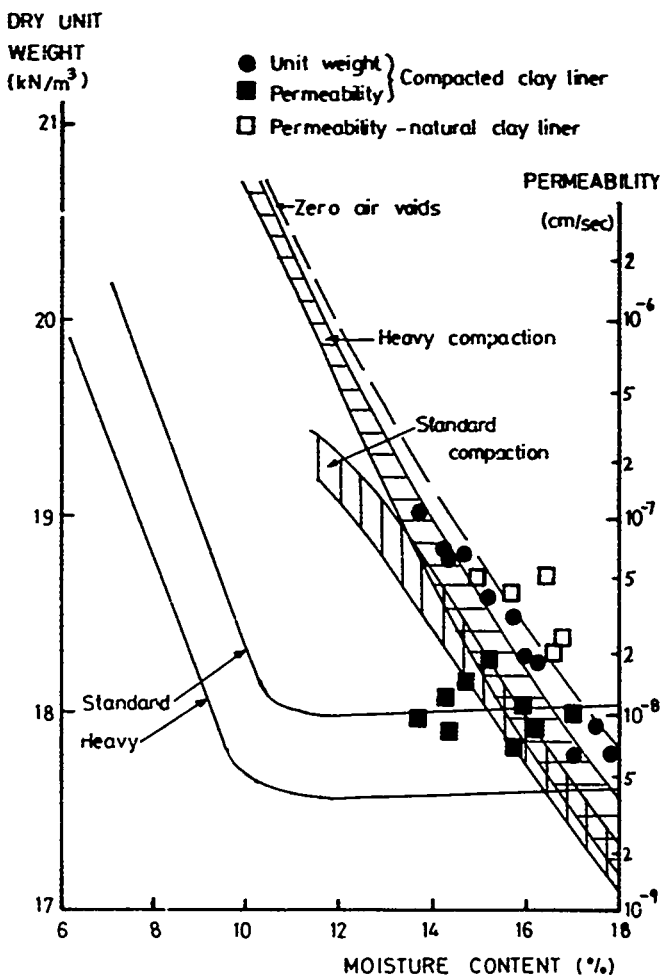
Fig.7 Properties of the Clay liner

Data from tests on the compacted clay of the liner are presented in figure 7. The earthworks were undertaken using an 'end-result specification', i.e. acceptability of the work is based on the end result rather than on strict adherence with a specified method of working. Quality control was undertaken by specifying that the clay should be compacted in accordance with the relevant Department of Transport specification (1976) as regards weight of compaction plant, number of passes of the roller, etc. Quality assurance was achieved by checking that the compacted clay had the appropriate moisture content and density values (as stated previously) together with a limited number of permeability tests and pressure testing of the completed liner. After placement all of the material was well wet of Proctor optimum with dry unit weight values close to the theoretical curve for 100% saturation - the compacted clay was generally denser than the laboratory samples formed using either standard or heavy compaction. The permeability of the field specimens is in keeping with the laboratory data obtained for heavy compaction and is well below the requisite  $10^{-7}$  cm/sec. These data vindicated the method used for the quality assurance/control of the clay liner.

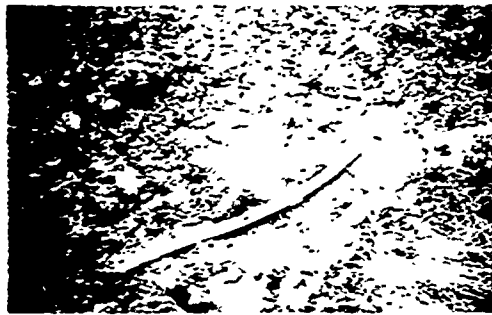
Fig. 8 Relief Drain Connection

drain pipe shown in figure 8 carried the water out of the site via the breach in the dam. Figure 8 shows a section of the outfall relief pipe in between the clay seal and the temporary bund (on the right-hand-side) and a temporary access across the breach (on the left-hand-side).
